Intel® Xeon™ Processor

Specification Update

June 2003

Document Number: 249678-027

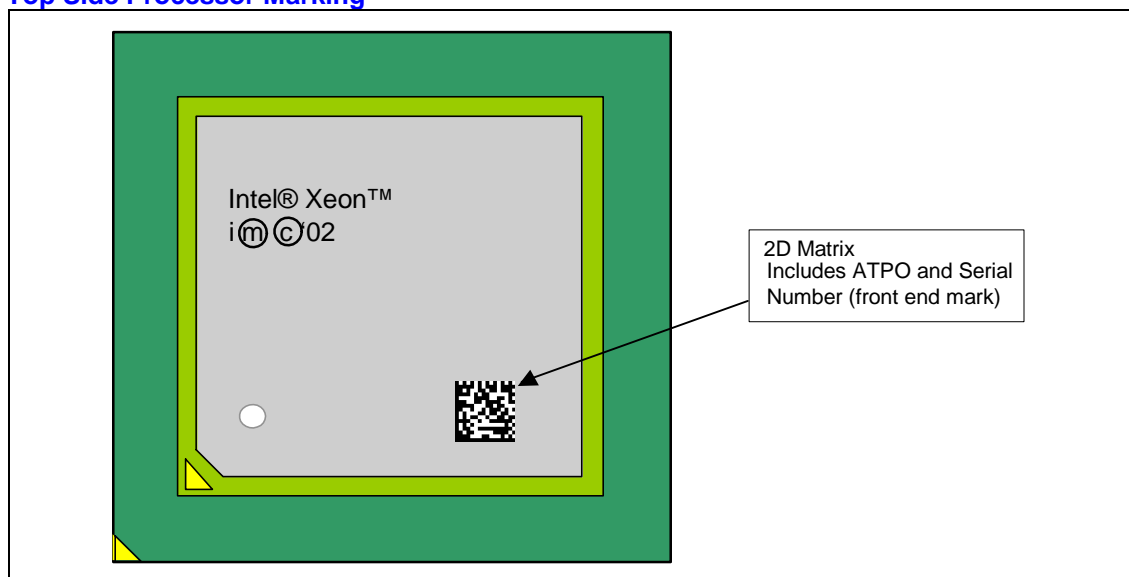
Figure 3. Top Side Processor Marking

Intel® Xeon™ Processor , 512-KB Cache, 400 and 533 MHz FSB Markings, (603-pin interposer INT-mPGA package and 604-pin Fc-mPGA2 Package)

Version	Description	Date
-001	Initial Release.	May 2001
-002	Added errata P27-P28.	June 2001
-003	Updated erratum P25.	June 2001
-004	Added RCPPS, RCPSS, RSQRTPS and RSQRTSS instruction specification clarification.	July 2001
-005	Added errata P29-P32. Added Unused outputs specification clarifications.	August 2001
-006	Added errata P33-34. Production mark update to include 2D matrix	September 2001
-007	Added 2 GHz frequency, D0 stepping and FC-BGA package information Added DP Platform Population Matrix Updated Summary of Errata table with applicable "Fixed" & "No Fix" errata plans Updated Errata P32	October 2001
-008	Added Erratum P35 Updated Summary of Errata Table with latest errata status Added Documentation Changes P1-P5	November 2001
-009	Added errata P36 and P37. Added Documentation Change P6. Updated Summary Tables with latest errata and documentation changes.	December 2001
-010	Added Documentation Changes P7-P11. Added Errata P38-P44. Added new processor with Processor Signature=0F24h B0 Step. Added new Sspec processors to Processor ID and DP Matrix tables. Added new package markings(Figs 3,4) for 512KB Cache processor.	January 2002
